2012 Operations, Maintenance, and Monitoring Report

GIWW - PERRY RIDGE WEST BANK STABILIZATION

State Project Number CS-30
Priority Project List 9

June 2012
Calcasieu Parish

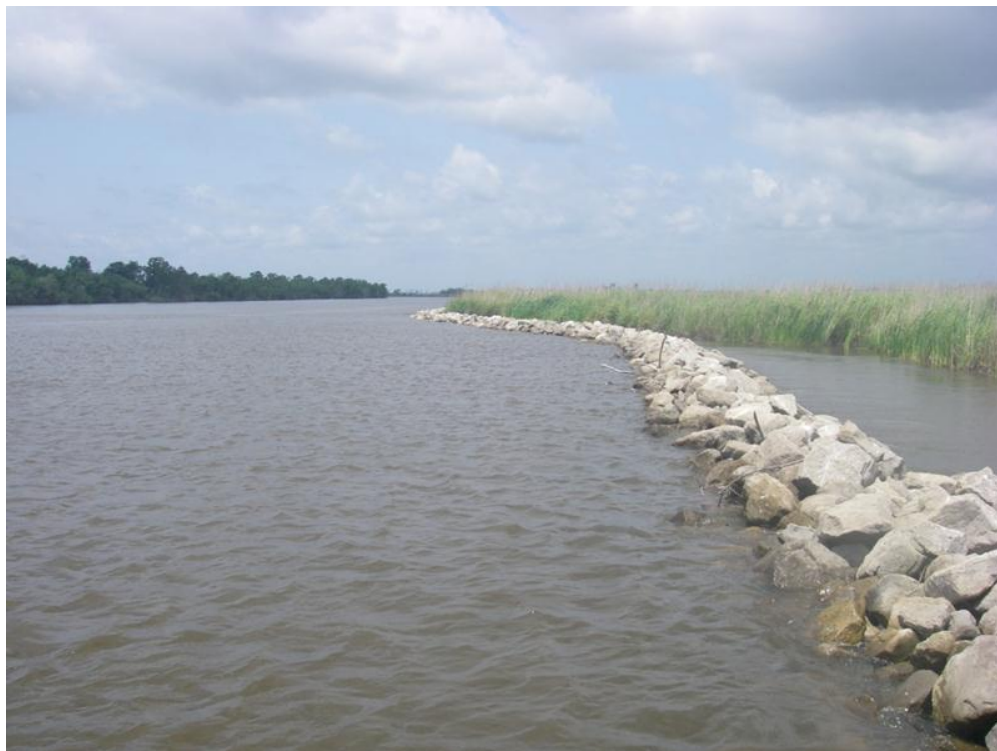
The dike is in very good condition. (Appendix A, Photo 1) There was one area noted where rock had been displaced by a barge. (Appendix A, Photo 2) A second location was noted where it appears rock has been moved creating a 7 foot gap in the rock dike (Lat/Long N30° 03' 34", W93 ° 41' 16"). A gap has formed in the earthen plug directly behind the gap in the rock dike. The water is channeling through the cut in the earthen plug into the marsh creating a fairly substantial current behind the dike. (Appendix A, Photo 3-4) At this time a survey of the rock dike and earthen plug are recommended in order to determine the best course of action. These two areas will continue to be monitored.

Photo 1, Typical Rock Dike.

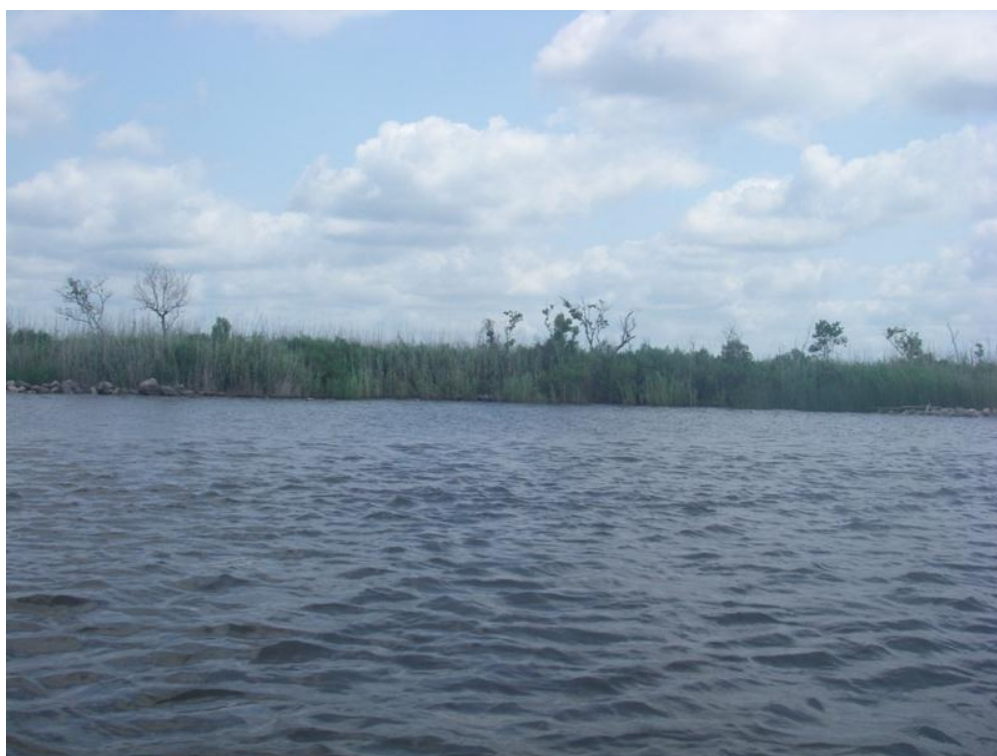
Photo 2, Rock Dike, Low Area of Displaced Rock Dike

A survey of the rock dike gap and earthen plug gap is recommended to determine the best course of action.

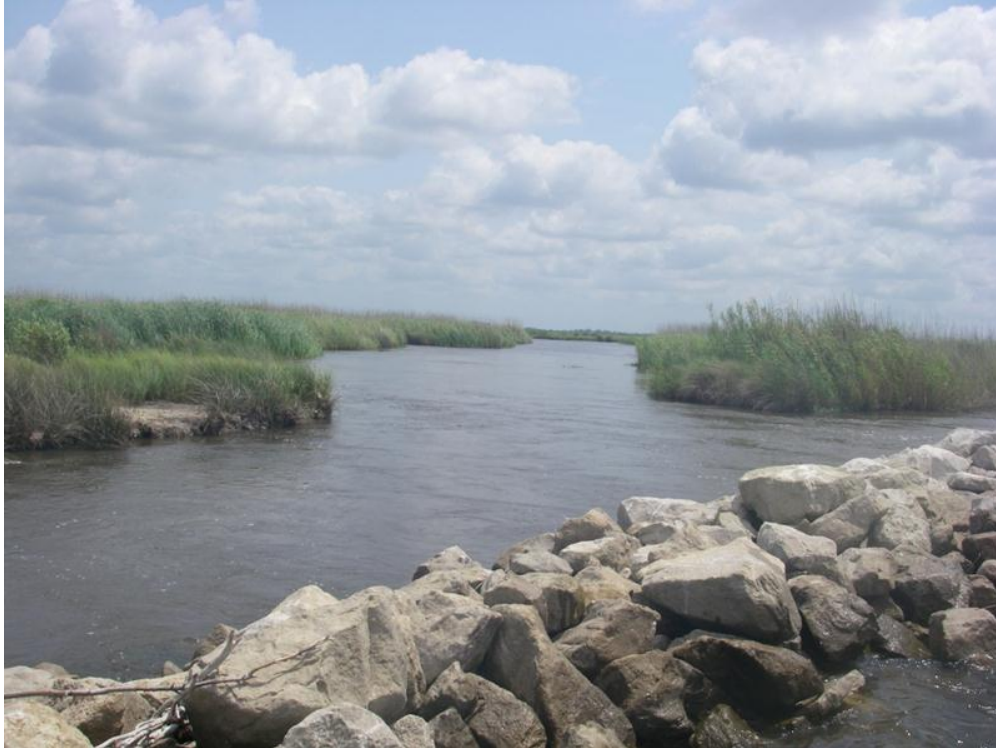
The rock dike is in very good condition and continues to function as designed to prevent GIWW bank erosion. There is one area of concern where the rock dike is gapped and the earthen plug (included in the original project design) immediately behind it has formed a gap. There is significant water movement channeling through the cut in the earthen plug into the marsh.

Photo 3, Gap in Earthen Plug behind Rock Dike, Water Flow Channeling into Marsh

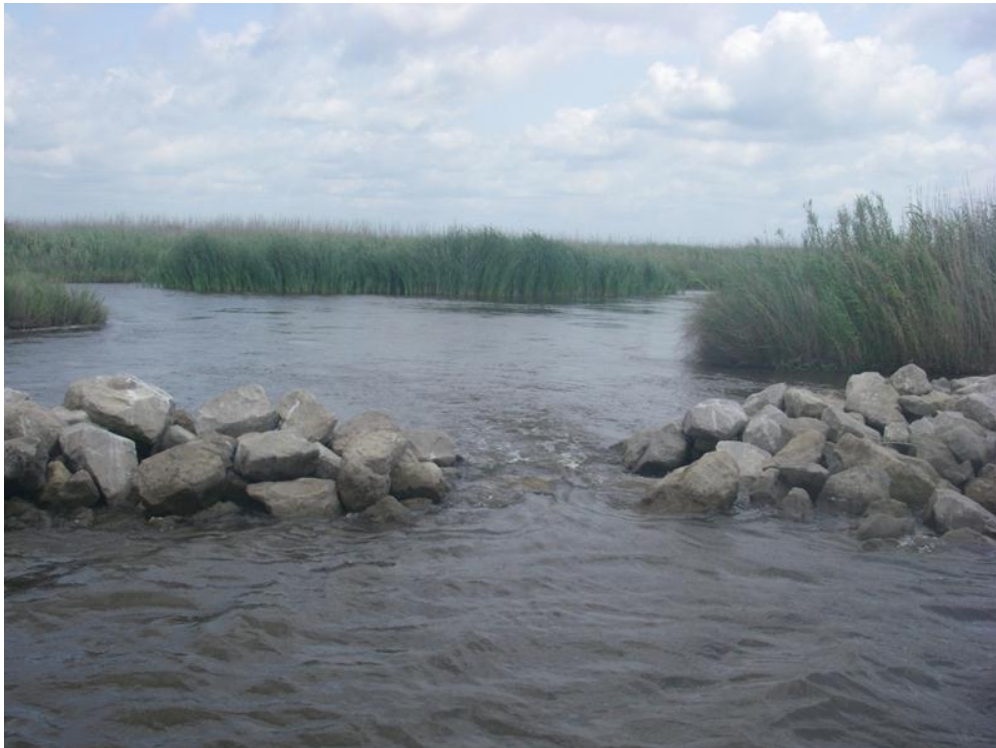
Photo 4, Water Flow through Displaced Rock Dike, Water Flow Channeling into Marsh
